DMS-DR 2508
NASA-CR 167,650

SPACE SHUTTLE AFRSI DESIGN CRITERIA
DEVELOPMENT TESTS IN THE NASA/AMES
RESEARCH CENTER 11x11-FOOT AND 9x7-FOOT
WIND TUNNELS USING MODEL 123-Ø (OS306A/B)

B. A. Marshall
Rockwell International
Space Transportation & Systems Group

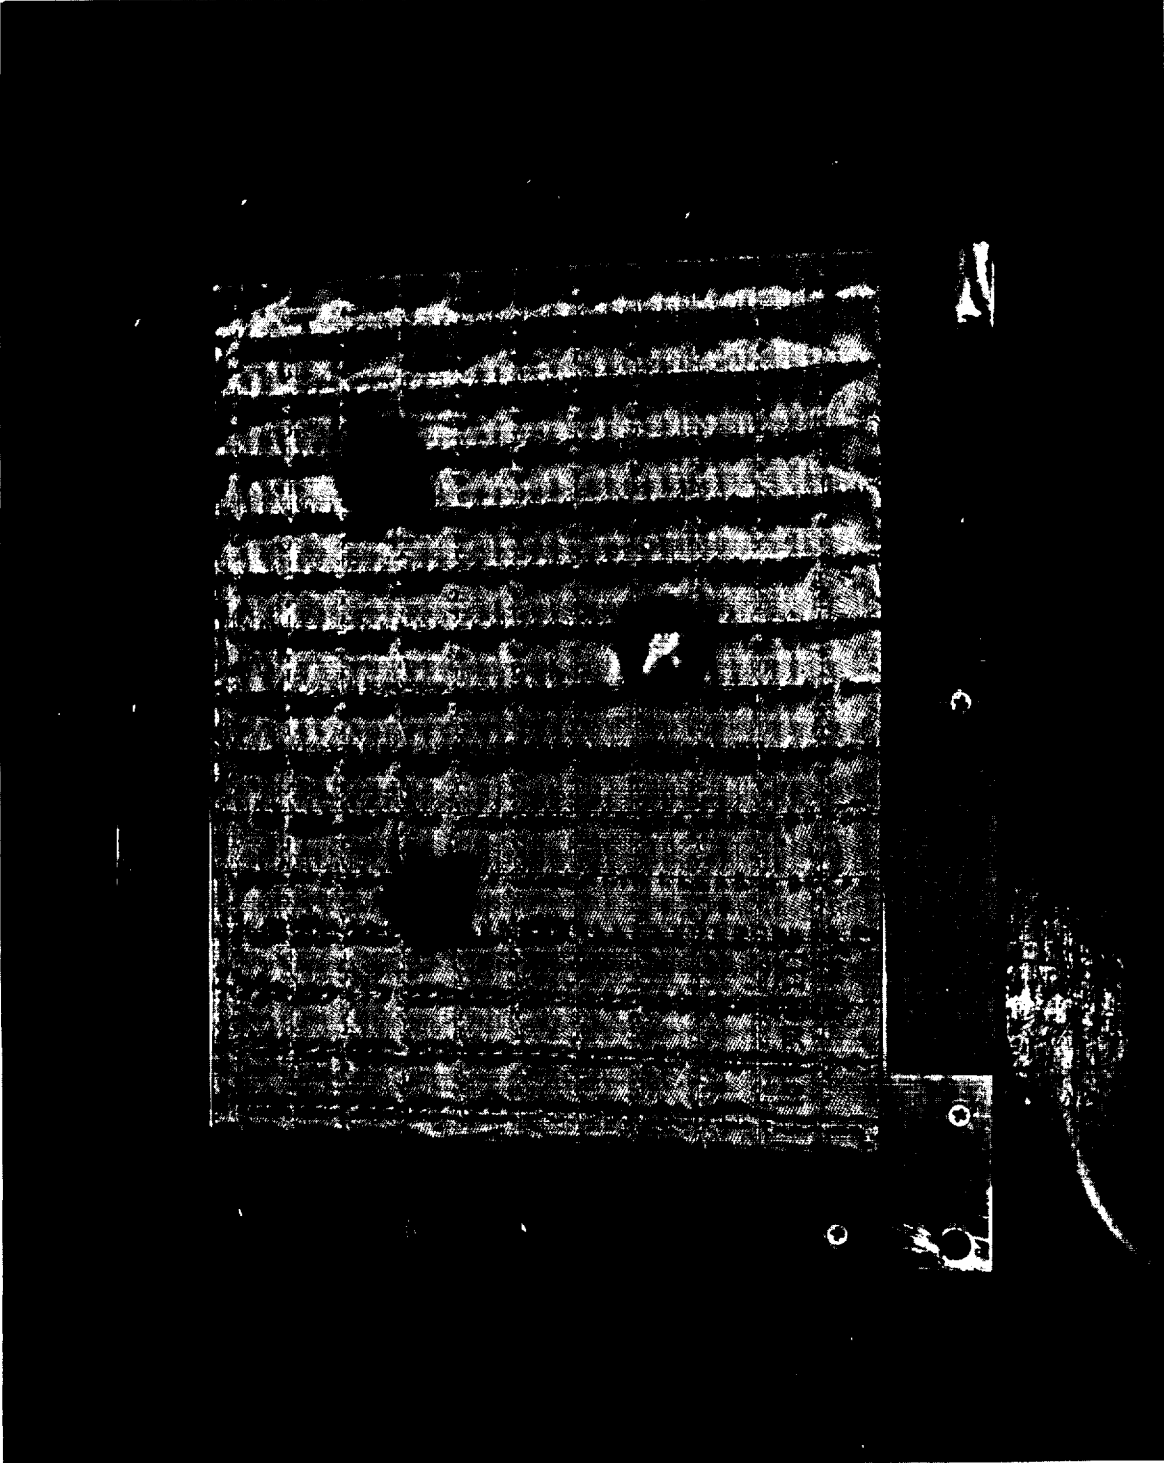
1115	42	7	No visible damage	Thick blanket
1116	42	6 1/2	No visible damage	Thick blanket
1117	42	8 1/2	Crack in repair, few threads missing	Densification repair - 1200°
1118	42	7 1/2	Loss of VHT repair	VHT repair - 1200°
1123	42	7 1/2	No visible damage	Broken stitches & gap filler
1124	42	8	Button was blown off during run, broken threads	RIV Bleed thru/spill -1800°
1126	43	5 1/2	No visible damage	Hydraulic Fluid Spill -1800°
1127	42	7 3/4	No visible damage	Thin blanket
1128	42	8	No visible damage	Loose edge and corner
1700A	42	9	Failure at 2 minutes, as seen on post-test video tape	1700° + Rain

t. Panel 1118, VHT Repair - 1200°

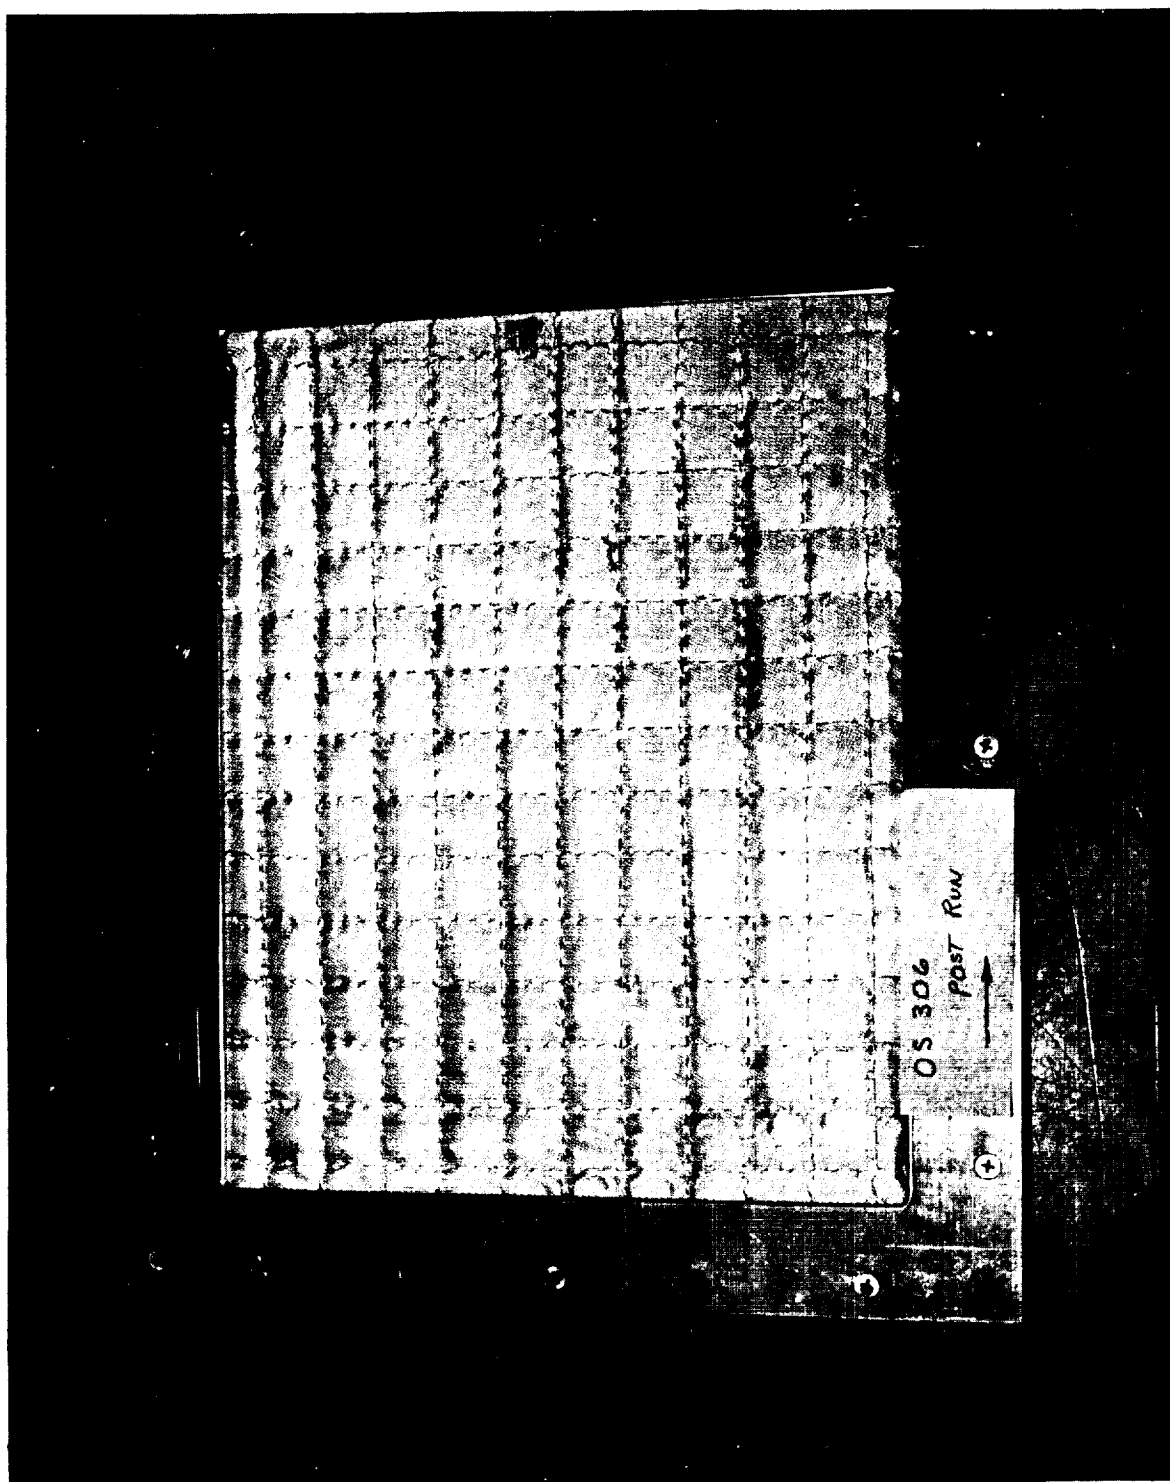
ff. Panel 1700A, 1700° and Rain

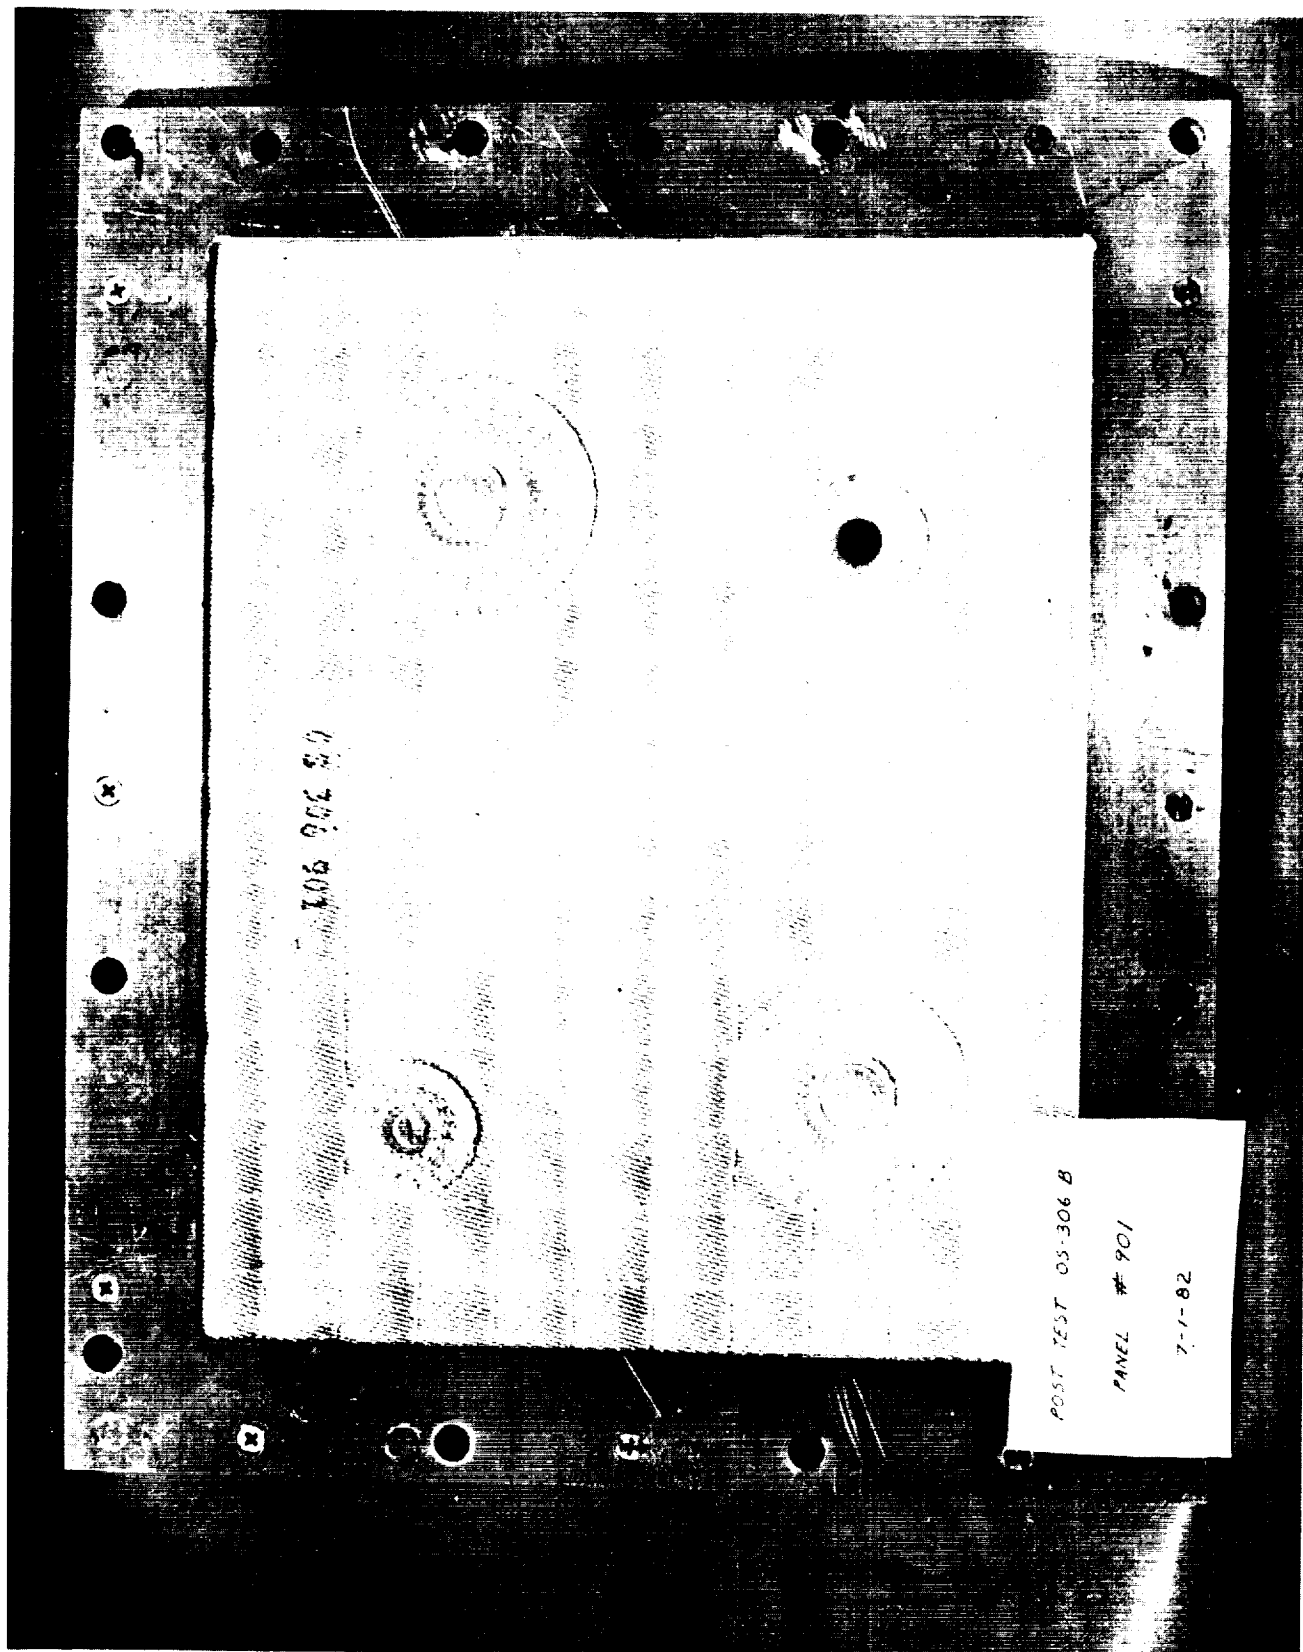
Panel	Q PSF	Time On Condition	*No. of Cycles	Test article Description	Damage to panels as a result of testing
901H	1060	50 Min	6	Plugged Penetrations	Minor fabric frays
902H	1060	50 Min	7	Unplugged penetrations	No damage
903	1060	50 Min	6	Large radius	No damage
904	1060	50 Min	6½	Sharp corner	Fabric frays
905	1245	50 Min	10	Unjointed; shock $\Delta p=2.25$	Broken threads

gg. Panel 901H, Plugged Penetrations

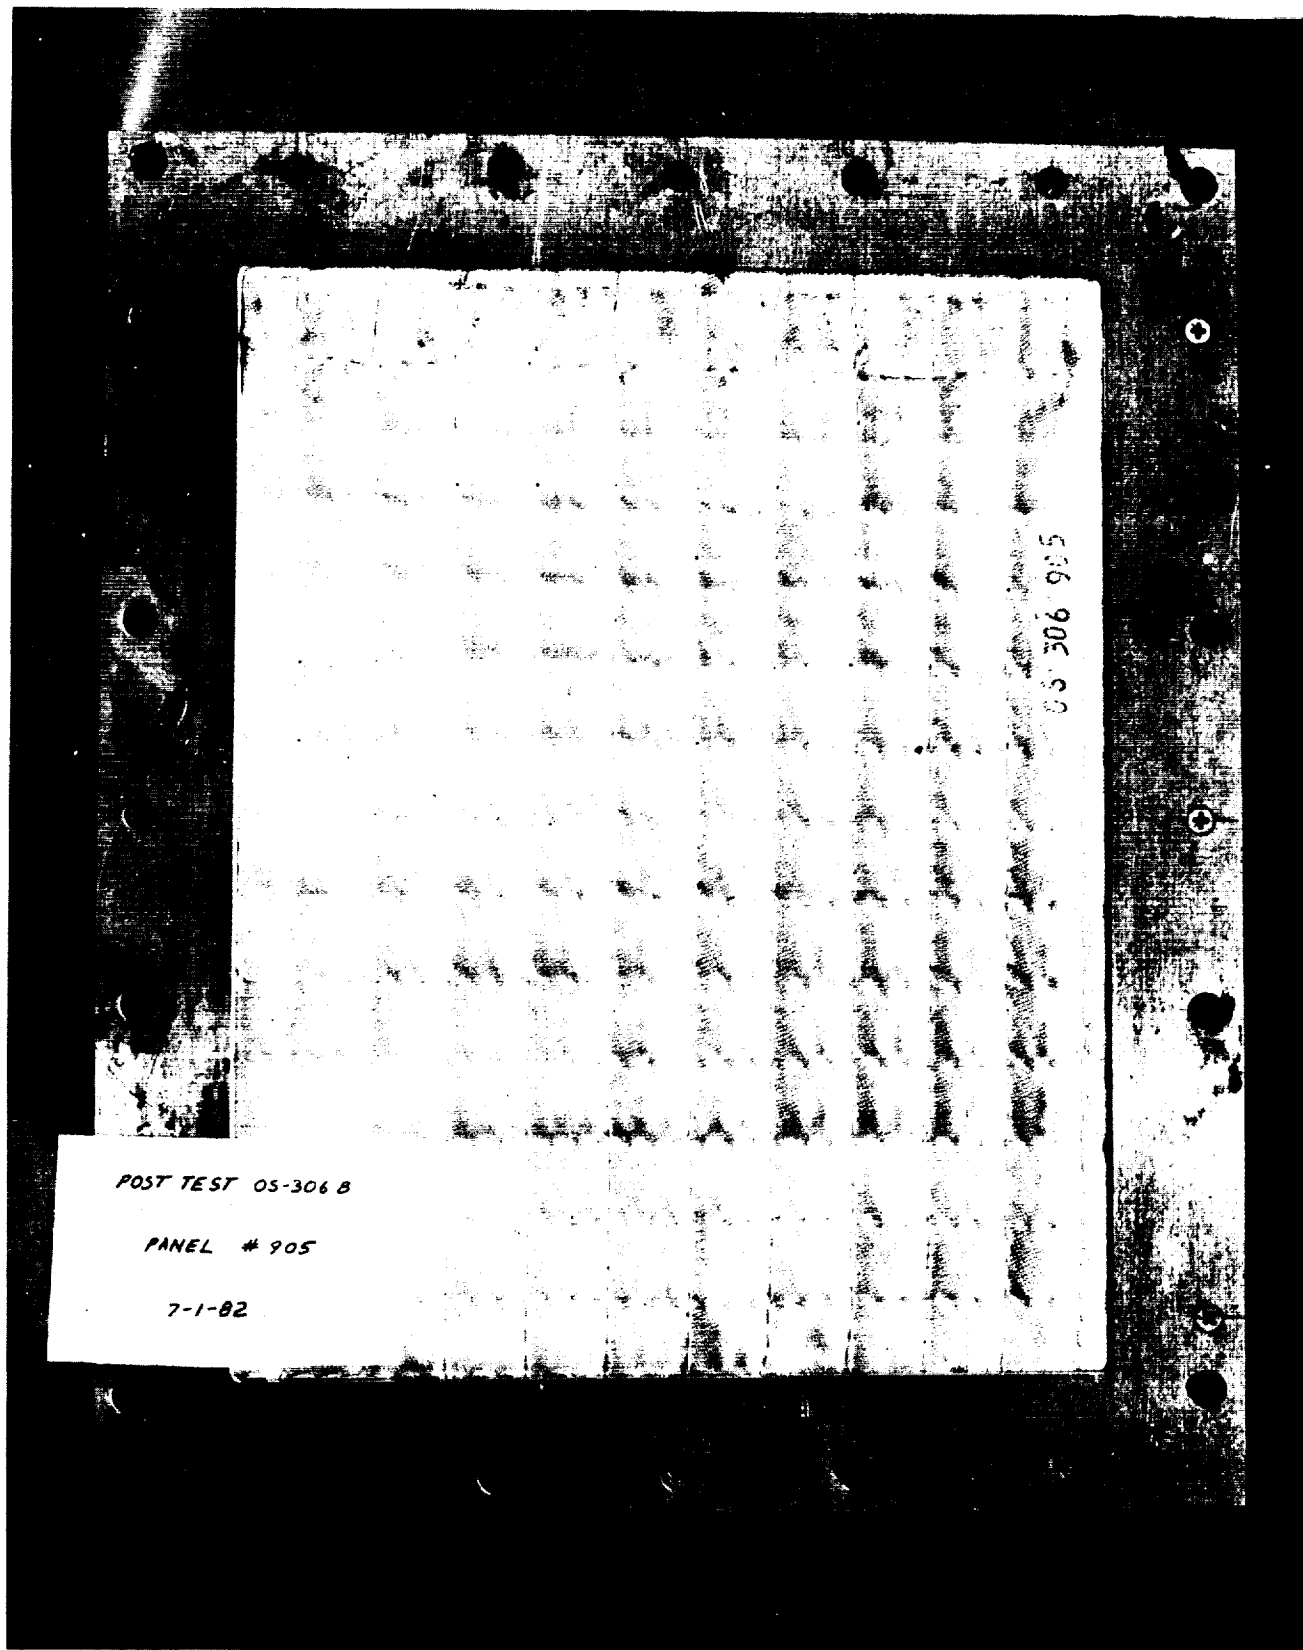
kk. Panel 905, Unjointed; Shock $\Delta p = 2.25$
